Unipolar Defibrillator?

BEHZAD B. PAVRI, REGINALD T. HO, VIKAS PATEL,
DAVID J. CALLANS, SHANE FOLEY,* and DUSAN Z. KOCOVIC

PAVRI, B.B., ET AL.: Unipolar Defibrillator? *An unusual case of "unipolar" pacing and myopotential oversensing leading to an inappropriate ICD shock in a patient with an implanted defibrillator is reported. The reasons for unipolar behavior in a system using a committed bipolar device are discussed. (PACE 2001; 24:244-246)*

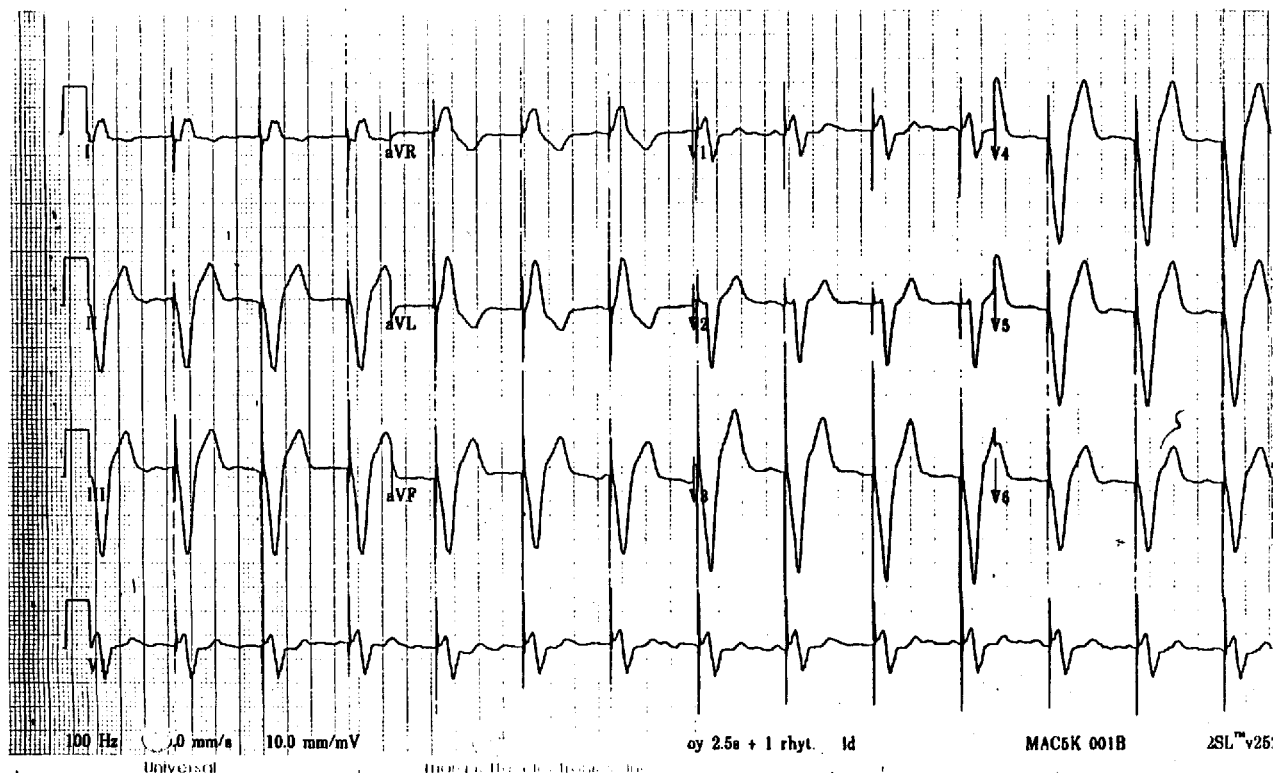
Figure 1. A 12-lead electrocardiogram obtained after ICD implantation is shown. The rhythm is atrial fibrillation with electronic ventricular pacing with large amplitude pacing artifacts consistent with unipolar pacing configuration.

demonstrated a bipolar R wave of 11.5 mV, pacing threshold of 0.6 V at 0.5 ms, and a bipolar pacing lead impedance of 456 ohms. The leads were correctly reconnected and successful defibrillation was now achieved twice with 17 J; lower energies were not tested. The 12-lead ECG following revision no longer revealed the large pacing spikes that were evident in Figure 1.

Based on this reasoning, the patient was taken back to the electrophysiology laboratory for revision of the ICD system. It was immediately confirmed that the RV and SVC coils were indeed reversed in their connections at the header. The leads were disconnected and ventricular lead testing with an external pacing system analyzer
